A LANDSLIDE HAZARD ASSESSMENT APPROACH FOR TOWN PLANNING IN NTCHEU DISTRICT

MSc (ENVIRONMENTAL SCIENCE) THESIS

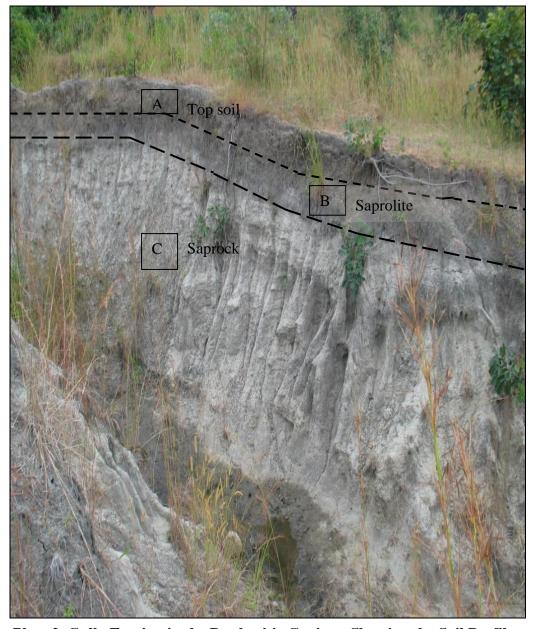
Plate 2. Gully Erosion in the Perthositic Gneisses Showing the Soil Profile.

Erosion in the weathered perthositic gneisses has left behind gullies measuring 4m deep in some instances (Plate2). These gullies gave an opportunity for the soil profile to be studied in the area. Generally, it was found that the slopes were made up of 50cm of top soil that overlay approximately 90cm of saprolite.

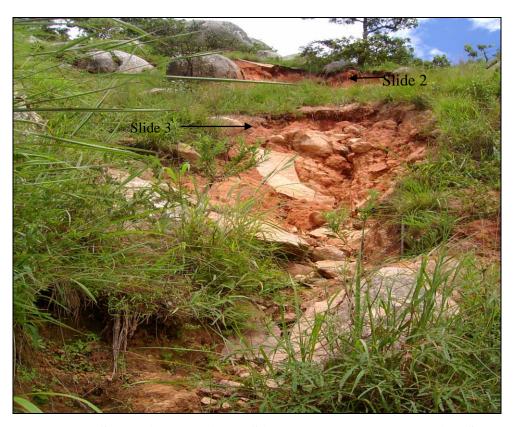
Plate 3. The Successive Rotational Slides on the Eastwards Facing Scarp.

This is defined as the occurrence of a series of individual rotational slides one above the other on a slope (Haefeli, 1948). These slides (slides 1 to 3) were shallow, at most 1.5m deep, and their 'heads' were between 5; 3 and 2m wide respectively. The landslides produced debris materials which got transported over a distance of 6 to 12m on slopes measuring 20° to 30°. The slopes were devoid of trees apart from a few which were widely scattered (Plate 3).
